INDOOR AIR QUALITY TESTING SERVICES

COVINGTON MIDDLE SCHOOL

606 SOUTH LEXINGTON AVENUE
COVINGTON, VIRGINIA 24426

ECS PROJECT NO. 47:20796

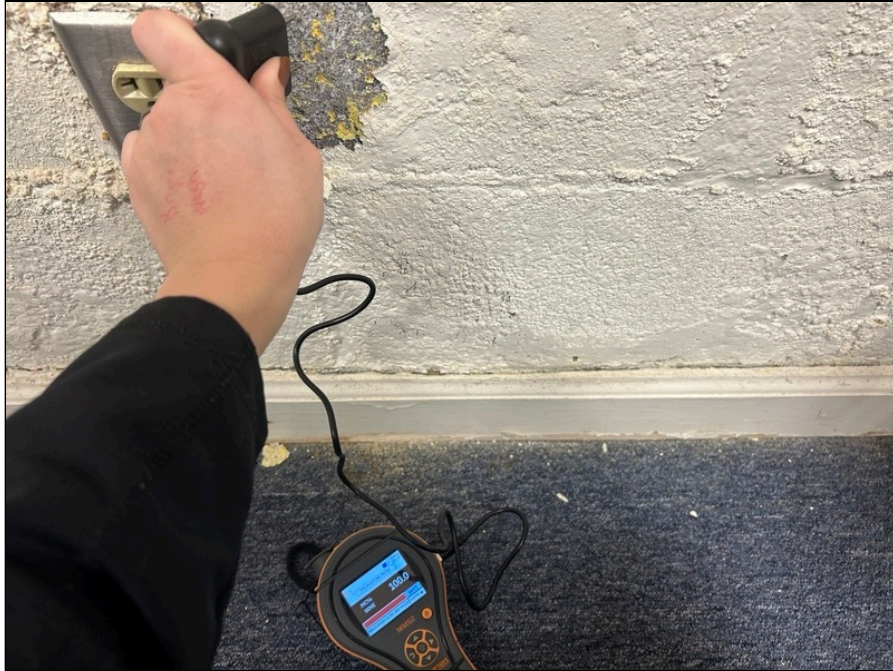
Elevated relative moisture measurements were noted in Room 111, and the Dressing Room and Dressing Bathroom in the Auditorium. The components impacted consisted of the concrete masonry unit (CMU) walls and the wooden baseboards.

Location	Building Component	Substrate Material	Moisture Content (%)
Auditorium - Dressing Room	Walls	CMU Block Walls	100
Auditorium - Dressing Room	Baseboards	Wood	37
Room 111	Wall	CMU Block	84.4

1 - Auditorium Dressing Room - CMU Wall (100% moisture content)

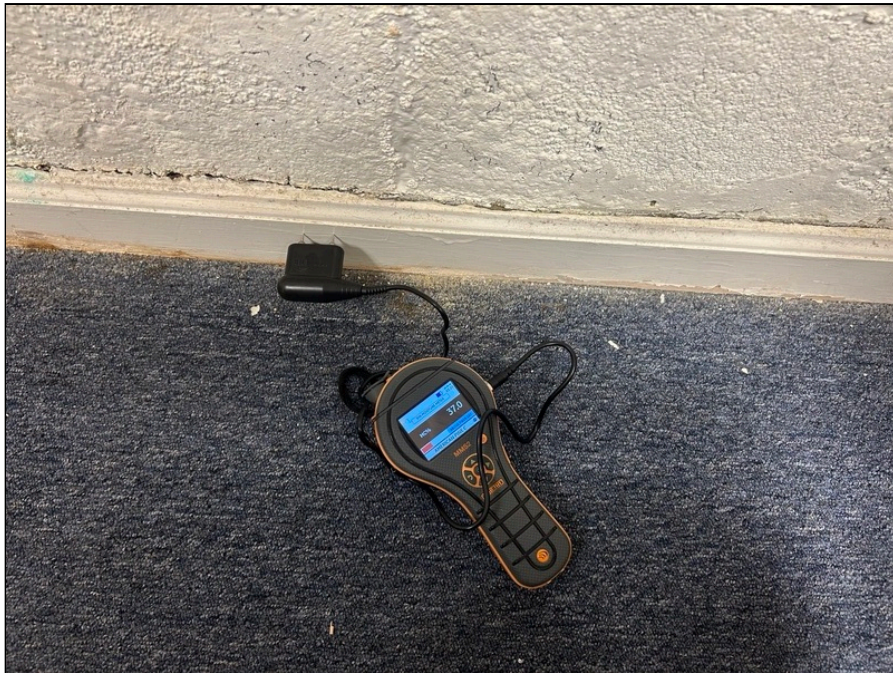
2 - Auditorium Dressing Room - Baseboards Wall (37% moisture content)

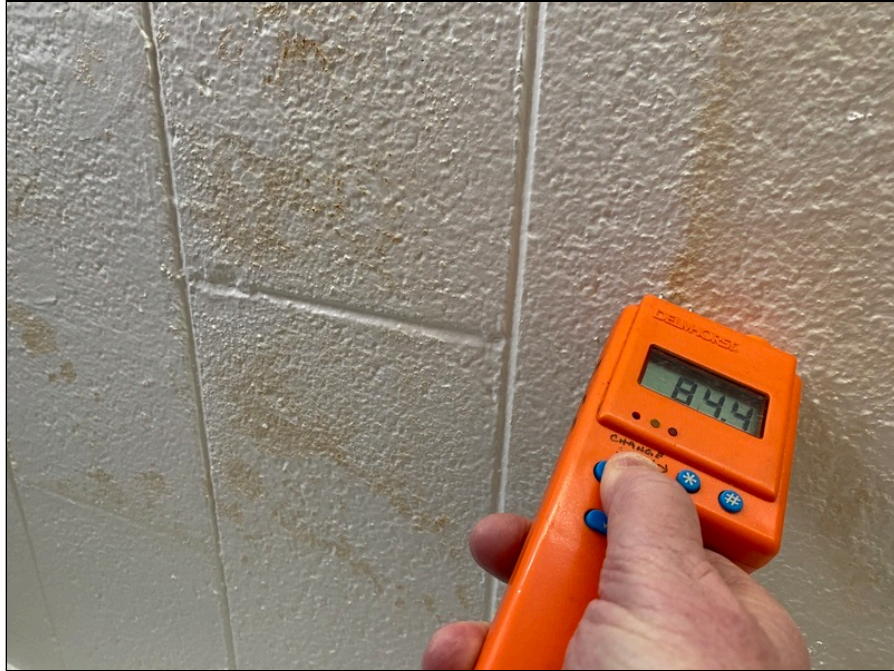
3 - Room 111 CMU Block Wall (84.4% Moisture Content)

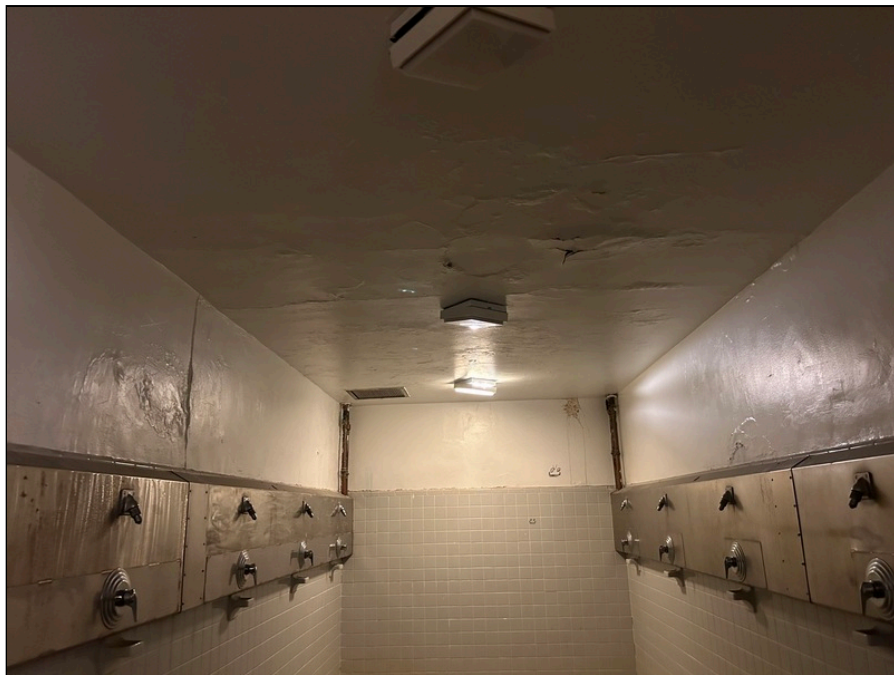
Additionally, ECS observed areas in classrooms and hallways with water damaged plaster ceilings, ceiling tiles and insulated piping above drop ceilings that appeared to have water staining. The plaster ceilings, ceiling tiles and pipe work did not appear to be wet and active water leaks were not noted in these areas. ECS observed ceiling damage potentially from past water leaks in the locker rooms and shower areas within the gymnasium. These areas were also found to be dry when tested with a moisture meter.

4 - Locker Room Shower with water damaged ceilings; Areas teste dry..

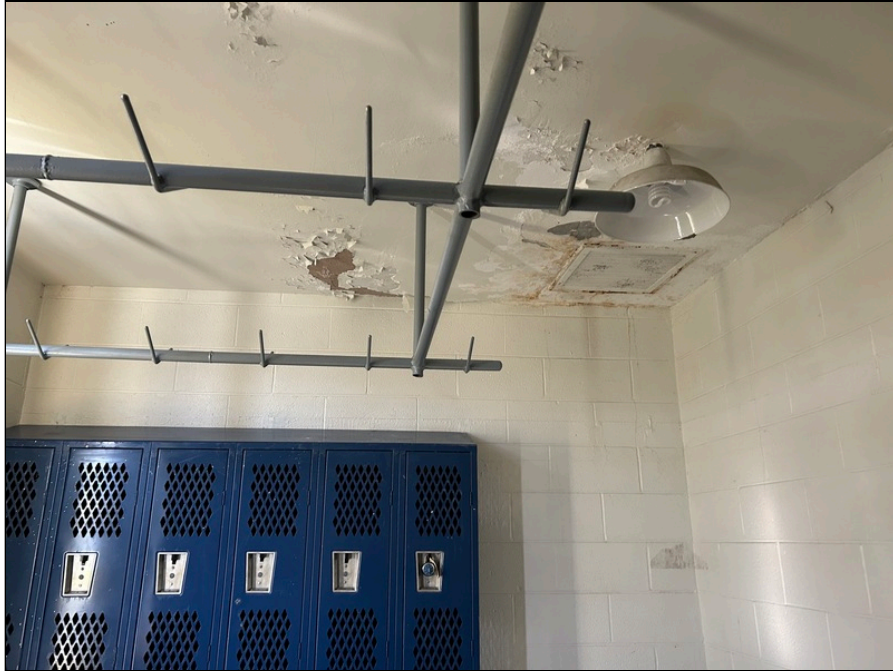
5 - Water damaged ceilings in the locker room area; Areas tested dry.

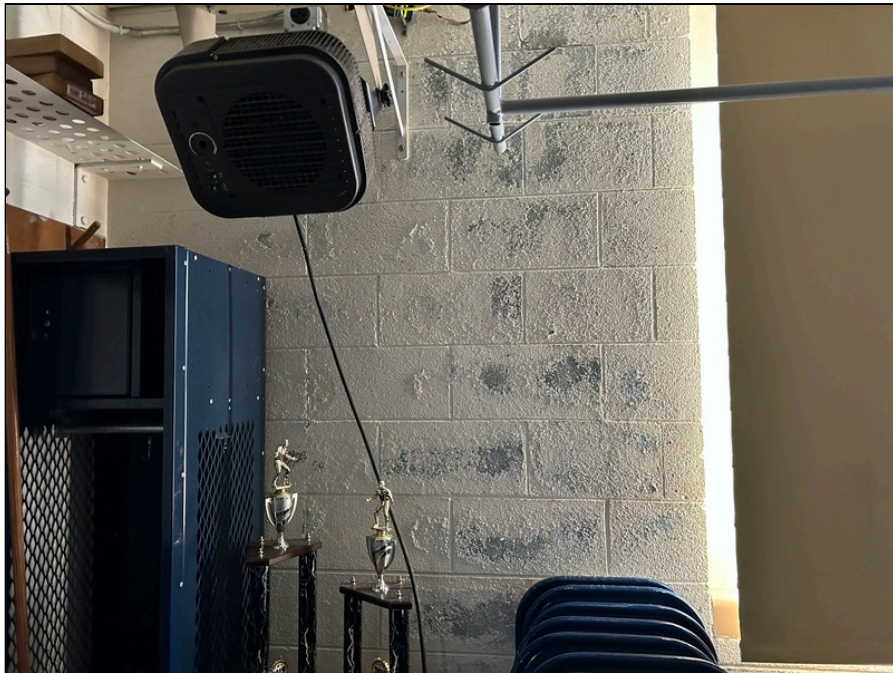
During the site visit ECS also observed several exterior CMU block walls throughout the interior of the building that appeared to have flaking peeling paint and efflorescence, indicative of prior potential moisture intrusion issues; however, none of the CMU blocks probed with the Protimeter indicated a high moisture content with the exception of the Auditorium dressing rooms and Room 111. Active moisture intrusion was also observed however in the basement boiler room for the original building (also reference pictures at the end of this report).

6 - Example of efflorescence on an exterior CMU wall - indicating potential longer term moisture intrusion.

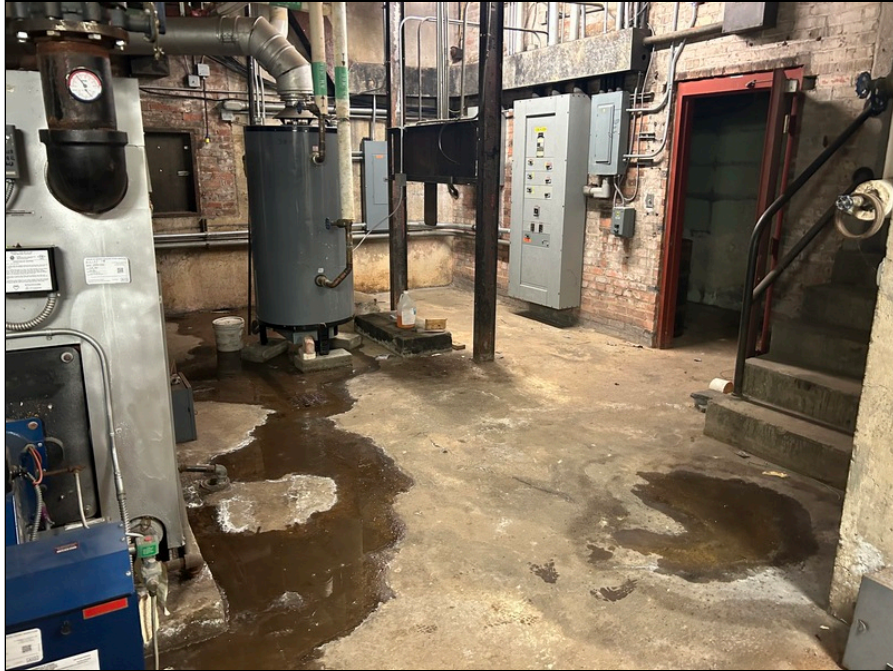
3) As typical with any school of this age, sporadic water damaged ceiling tiles and other water damaged materials were observed in various locations within the school. ECS observed two active water leaks in classrooms/student occupied areas; Using a moisture meter, ECS was able to show that both of these areas were still wet. One in the dressing room off of the auditorium, and in Room 111. Maintenance staff quickly identified the sources of both leaks and were addressing them while ECS was still onsite. During the survey ECS also observed active water intrusion in the basement boiler room of the original school building (see also attached pictures). As good practice, this should be reviewed and corrected by a building envelope specialist as a long term abatement measure. In general, the mold air samples collected in various locations in the school were acceptable and did not show significant elevations in spore counts although this sampling was limited. ECS observed a slight elevation in the sample collected from the Cafeteria/kitchen; however, it is believed that this may be due to water sources that are typical in kitchen and cafeteria area. It should also be noted that comparison outdoor samples would be expected to show low outdoor spore counts due to the time of year and recent snow events.

7 - Active water leaks in the boiler room for the original school.

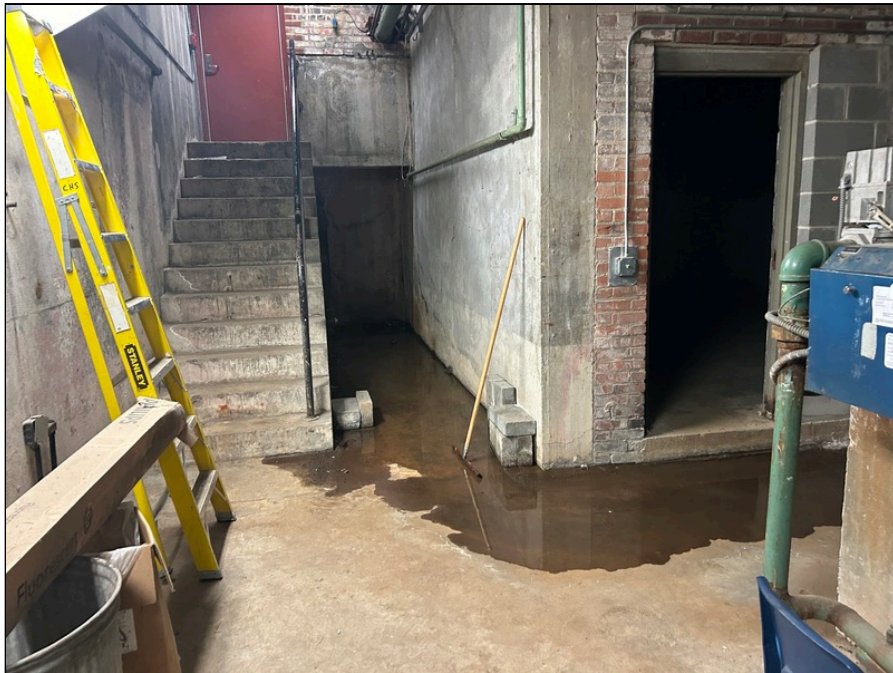
8 - Active water leak in the boiler room for the original school.
