# Covington Middle School

## *Mechanical Systems Assessment Report*

Facility Dynamics Engineering

March 03, 2025

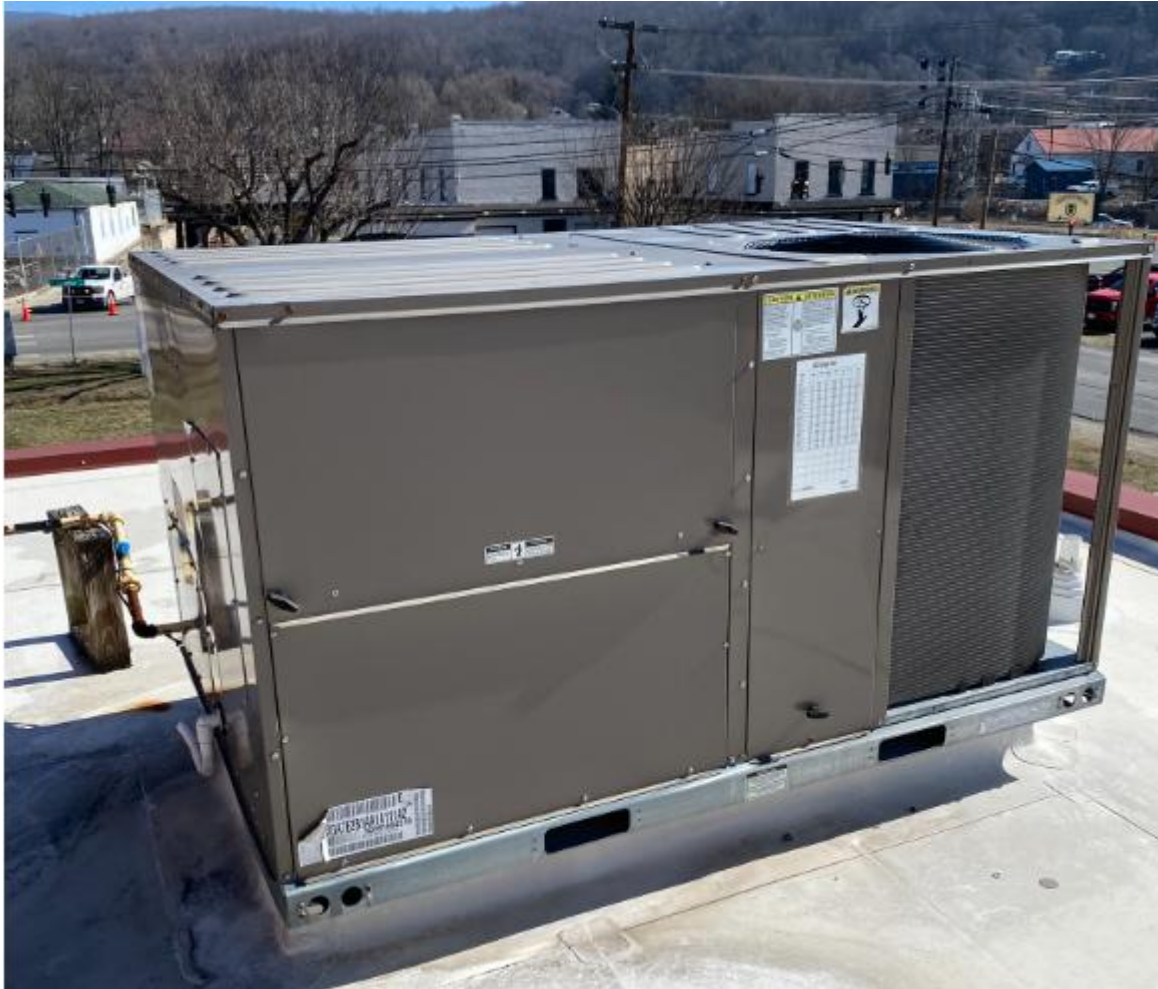
- There is no outside air being delivered via the HVAC systems to the kitchen or cafeteria areas.
- There is no outside air being delivered to the music room located next to the cafeteria.

Figure 1 – Kitchen Roof Top Unit – No Outside Air Intake

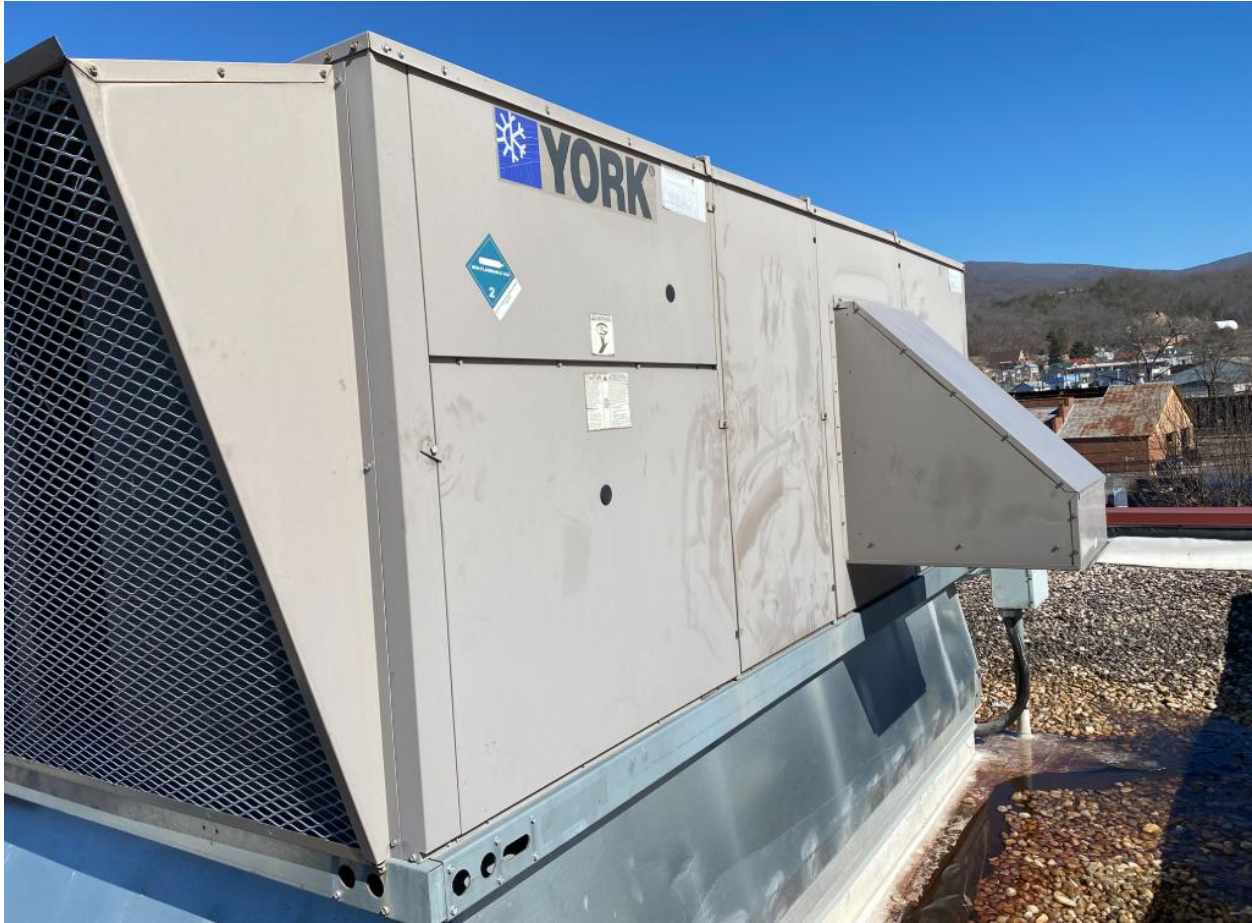
- There is only a minimal amount of outside air being delivered to the gymnasium and stage area. 1 of the 2 units has an outside air intake that is always open to the unit. The other unit only utilizes return air and does not have an outside air intake.

Figure 2 – Gym Roof Top Unit – with fixed, minimum Outside Air Intake Hood to the right of the unit

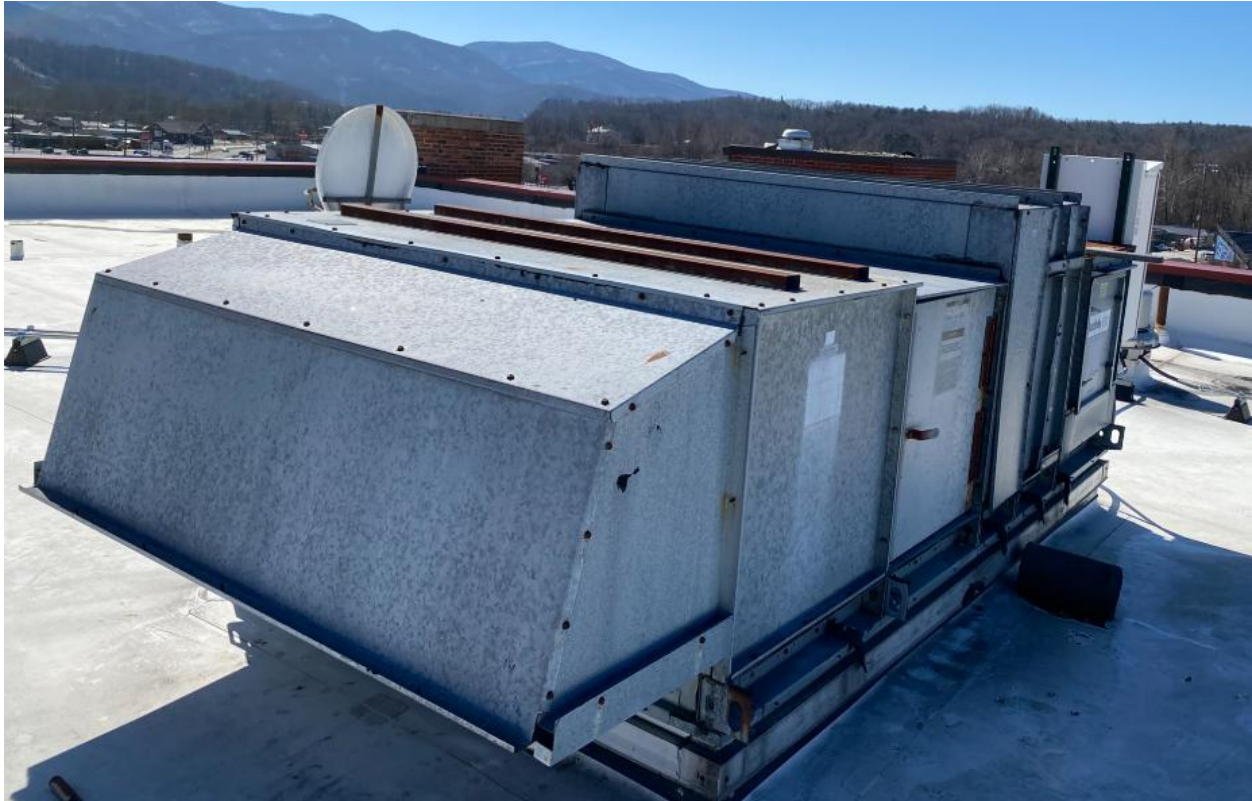
- Most of the classrooms are intended to receive outside air from RTU-4. This unit serves all 3 floors, but it is not operational. It was in the process of being renovated to get it functioning properly at the time of our site visit (but it was still off). The exact amount of time that this unit had been down (turned off) is unknown. However, it is believed that it has been down for a significant amount of time.

- RTU-4 has capacity to heat the air, only. There is no cooling source for this unit and thus does not have the capability to dehumidify during warm and/or humid conditions.

Figure 3 – Classroom RTU-4 (Dedicated Outside Air Unit). Note OA intake (at left of the unit) is approximately 40-50 feet away from the boiler stack discharge located at the far corner of the building (chimney) which is a more than sufficient distance away.

- It is highly recommended that RTU-4 be repaired and made operational before reopening the school to students
- It is recommended that, at some point soon, the airflow be verified and flow rates confirmed to make sure the proper amount of air is being delivered at each classroom (or other space) per the latest design drawings (from 1989).
- Consider replacing RTU with a new Dedicated Outside Air Supply (DOAS) unit. The unit should provide both heating and cooling and may want to utilize heat recovery from the building exhaust (mostly bathroom exhaust). This would allow for proper conditioning of the air prior to being supplied to the space. The new unit would likely also be more energy efficient.
